ENGINE WATER PUMPS

FOREWORD

The purpose of this booklet is to provide a basic overview of a water pump and information on how to avoid common reasons for water pump or cooling system problems, and best practices for water pump replacement and cooling system restoration.

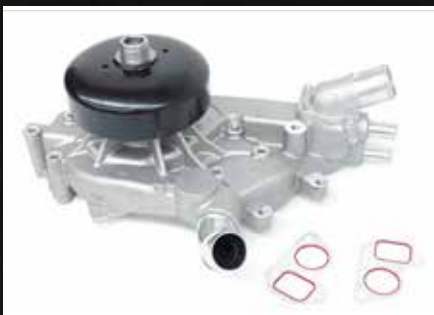
BENEFITS OF CASE HARDENED BEARINGS

Long life

High load capacity

Tough on the outside & flexible on the inside

Can better withstand an imbalance or vibration in the cooling system

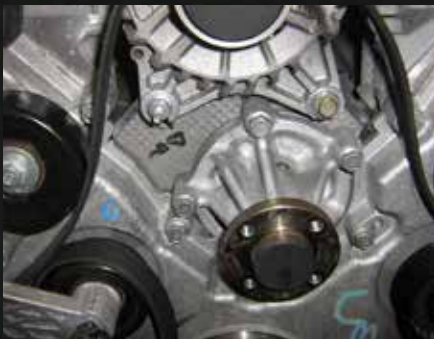
BENEFITS OF PRECISION CNC MACHINED SURFACES

Guaranteed fit with mating components

Inspected and tested to ISO9001:2015 standards

Prevents leaks

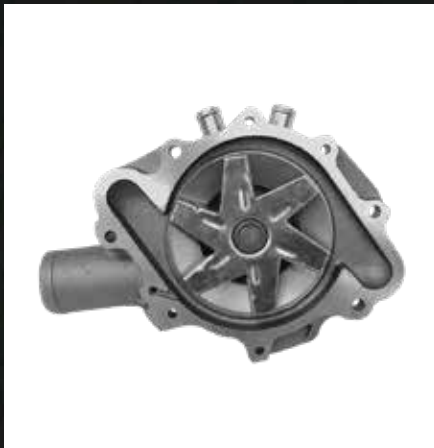
BENEFITS OF METAL IMPELLERS

Withstands high temperatures

Withstands chemicals

Performs at high RPMs

Will not deform

Withstands high torque forces

Will not shatter

Will not crack during press fit

Highly durable

Better for transits and storage

Withstands variables in high mileage engines

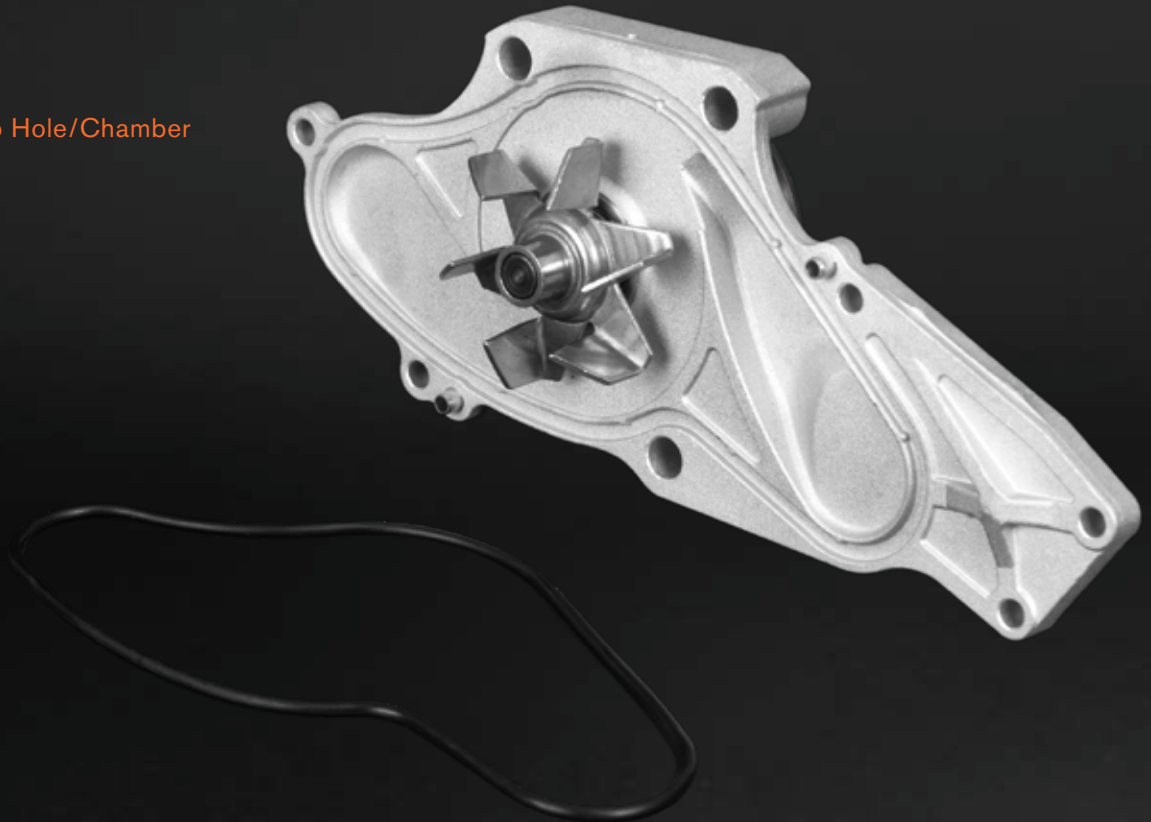
The water pump is responsible for pressuring and propelling anti-freeze/coolant and water mixture (coolant) through the cooling system. Five main components make up an engine water pump: the hub, bearing, housing with a weep-hole or chamber, seal, and impeller. Of these five, the water pump seal and the bearing are found to have the highest instances of failure.

Hub

Bearing

Housing with Weep Hole/Chamber

Seal

Impeller

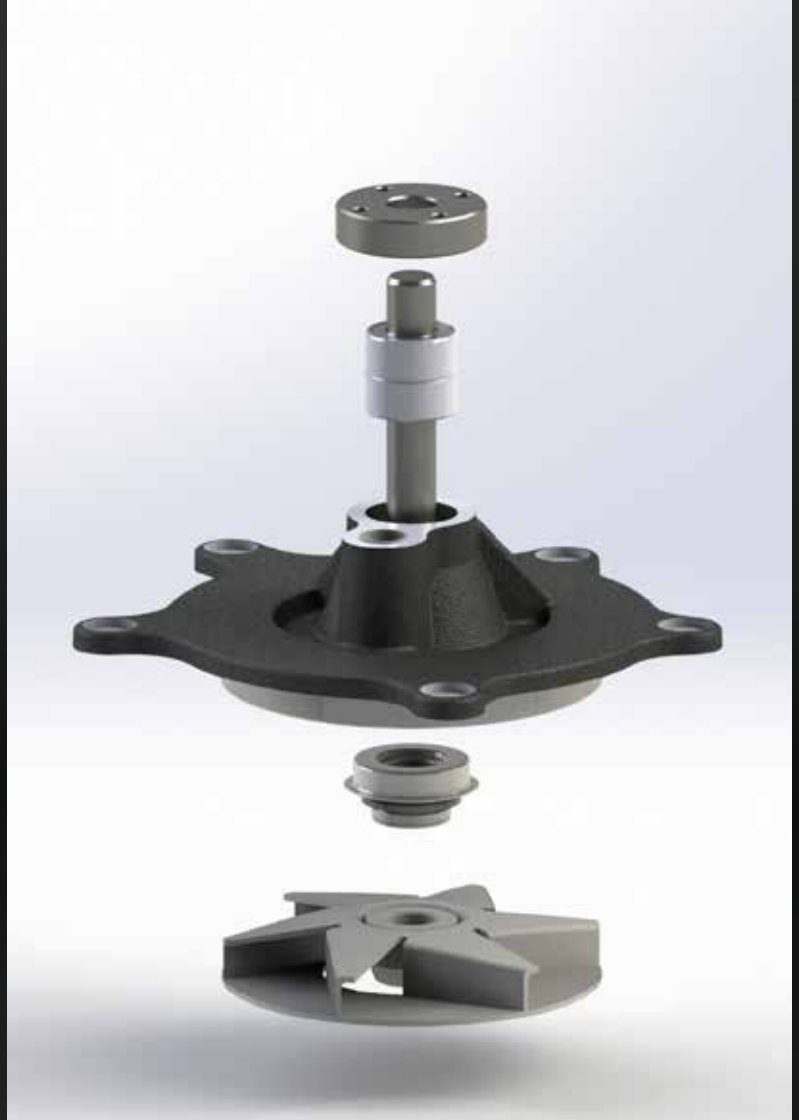
THE COMPONENTS OF A WATER PUMP:
WATER PUMP SEAL

The water pump seal is critical for water pump operation. The bearing rotates within the center of the seal, which turns the impeller, moving the coolant through the cooling system. The seal contains coolant within the housing or designed block cavity, and its critical function is to keep the coolant from contacting the water pump bearing.

A water pump leak will indicate an initial seal failure. A small amount of coolant will escape the water pump through the weep-hole or chamber. This is yet another design feature to keep coolant away from the water pump bearing. The water pump should be replaced if a leak is found from the weep-chamber after operation of the vehicle.

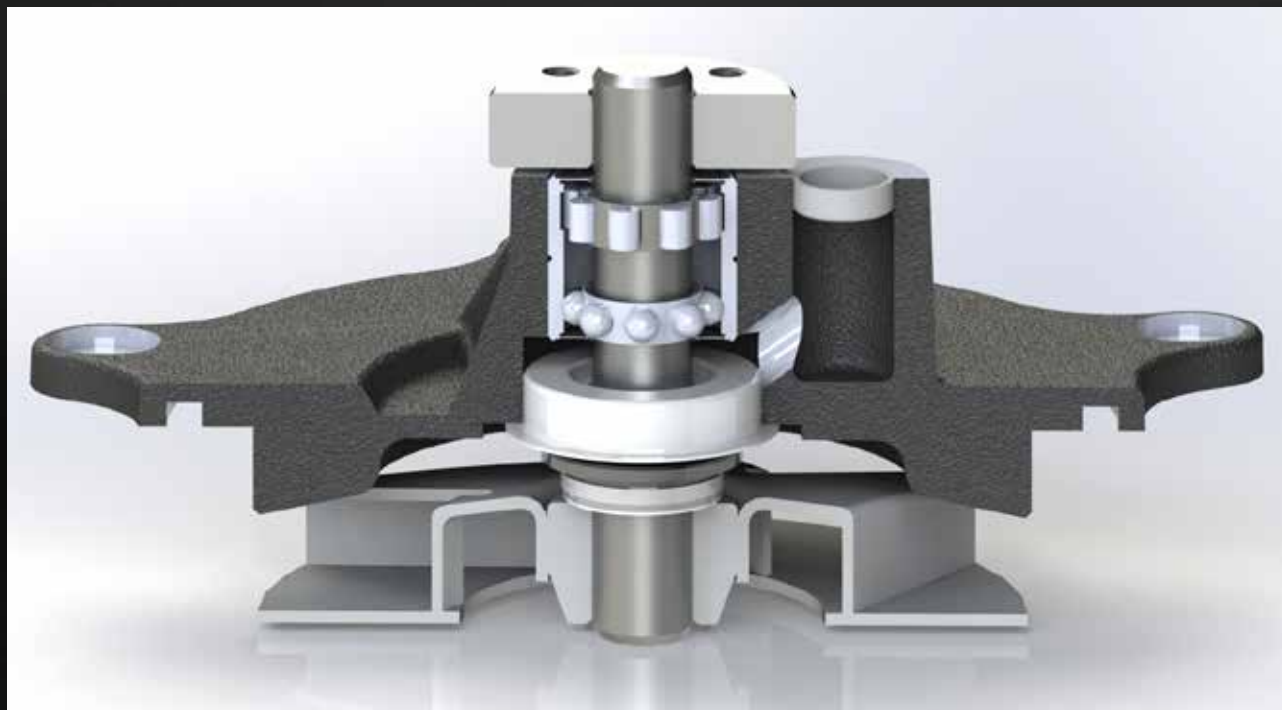
THE COMPONENTS OF A WATER PUMP:**WATER PUMP BEARING**

The water pump bearing allows for the water pump to rotate. The ball bearings and/or roller bearings (also known as an integral shaft bearing), are contained in a case packed with bearing grease. The two ends of the case are sealed, securing the bearing case. On one end is the press-fit water pump hub or pulley, and on the other end is the press-fit water pump impeller. A shaft rotates in the center of the bearing case. The bearing case is press-fit into the water pump housing along with the seal.

The seals on the water pump bearing case are not only designed to keep the bearing grease in, but to keep harmful engine residue and particulates out. It is important to note that the bearing seals will not withstand coolant. If coolant passes the water pump seal, it will enter the bearing case and washout the grease. If this occurs, the water pump has completely failed. It will begin to make loud noises, causing the water pump to consequently seize and break apart.

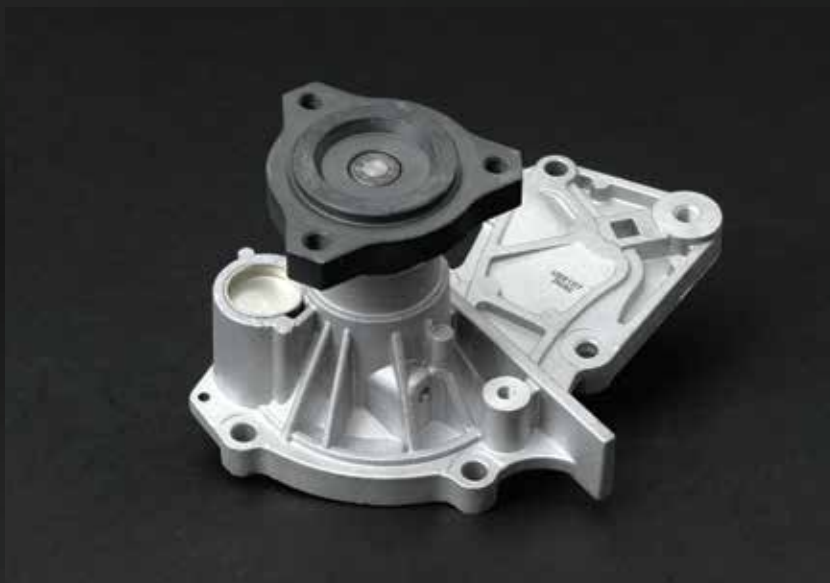
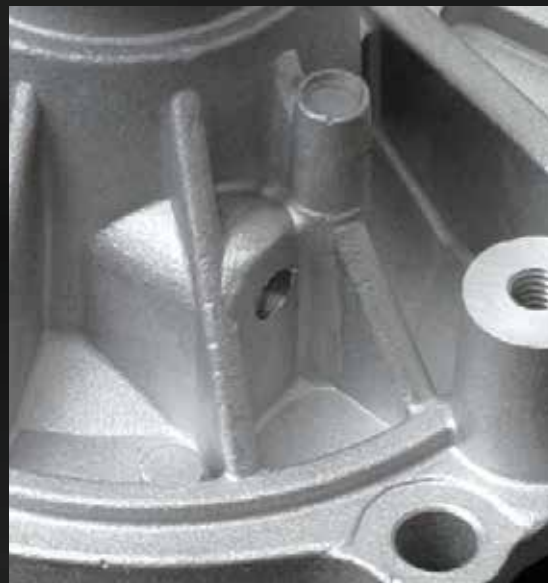
07 **THE COMPONENTS OF A WATER PUMP:** **WEEP-HOLE / CHAMBER**

Mechanical water pumps are purposefully designed with a weep-hole. The purpose of the weep-hole is to keep coolant away from the water pump bearing during seal failure and allows for coolant to escape during initial water pump break in. Many new OEM water pump designs now include a chamber surrounding the weep-hole. This weep-chamber allows the normal break in seepage to be collected and evaporate rather than a drip or two falling into the engine compartment or to the ground, alarming the customer and polluting the environment.

If a leak is still apparent or more pronounced after a few days of operation, a problem exists and a cause should be determined before a second water pump is replaced.

Failure to address a leaking water pump from the weep-hole will eventually lead to the coolant reaching the water pump bearing and ultimately destroy the water pump and cause catastrophic failure.

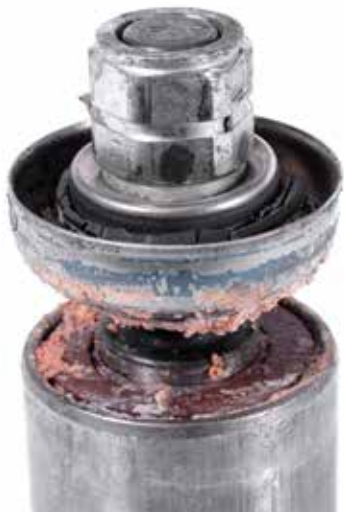
Seal Failure
Refer to Page 10

Like any other mechanical part, the water pump seal will eventually wear out. Even with the best maintenance schedule, parts have a limited service life. A common failure will begin with the appearance of a small amount of coolant from the weep-hole. This may go unnoticed until the fluid appears on the ground or the smell of burning fluid becomes apparent.

Poorly maintained or contaminated cooling systems is the other major contributor to seal failure. Rust and loose particles will eat away at the water pump seal.

The water pump seal can also be subject to conditions that reduce its service life or damage the component rather quickly. Imbalance in the system is the number-one contributor to rapid seal failure. Reinstalling the old fan clutch onto a new water pump can stress the seal and bearing as can a damaged fan blade or belt tensioners. Adding cold water to a hot radiator or over-heated cooling system can fracture different components including the water pump seal because of thermal expansion. Always wait for a cooling system to cool down before attempting any work or opening the radiator.

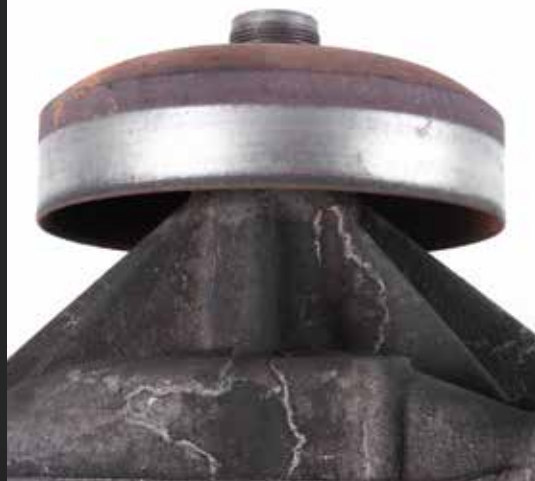
Bearing Failure
Refer to Page 11

The same imbalance that causes seal failure will eventually or immediately cause bearing failure. If the seal fails and coolant makes it to the bearing, the fluid will wash away the bearing grease and cause total bearing failure. This will seize the bearing and could lead to a snap of the bearing shaft. Over tensioned belts or faulty tensioners, along with a faulty fan clutch or broken fan will produce the necessary stress to damage or destroy the water pump bearing.

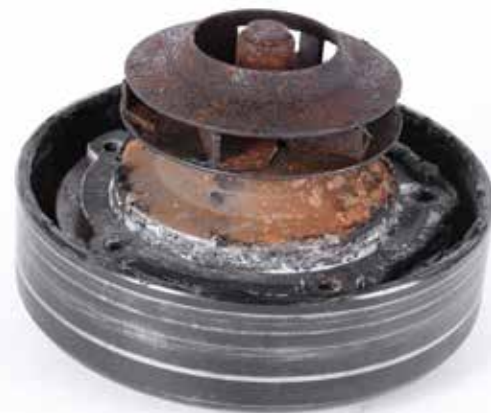
Leaking
Refer to Page 12

A water pump leak can originate from other areas besides the weep-hole. Incorrect tightening of mounting bolts, use of gasket sealant, or pinching of mounting gaskets and seals all can contribute to a leak. If addressed quickly, water pump failure can be avoided. If left unattended, a cooling system failure can result in overheating and engine damage.

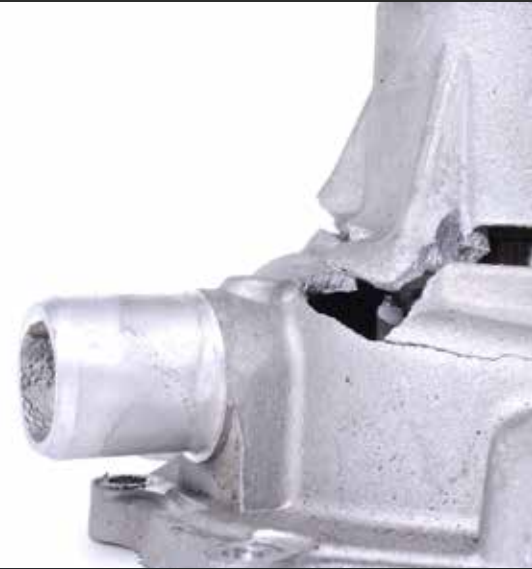
Breakage
Refer to Page 13

Water pumps are in most cases metal; either aluminum, cast iron, or steel. A water pump is a strong, rugged engine component built to last many years and miles. A break in a water pump is usually associated with major imbalance in the rotation dynamics of the water pump. Fractures are caused by over tensioning of, or faulty belt tensioners, over tightening of the mounting bolts, reuse of the original fan clutch, or incorrect tension of a new fan clutch, and misalignment of the mounting or belt systems. Incorrect tools used to install the water pump such as crow bars and hammers have led to this condition. Bearing seizure can also contribute to destructive failure.

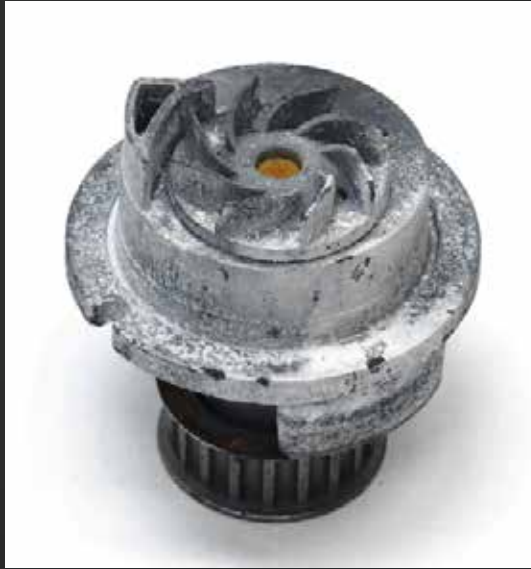
**Cooling System Problems:
Electrolysis**
Refer to Page 14

Electrolysis is the result of electricity flowing through the cooling system and causing an electrochemical charge on certain metals. This charge can cause damage throughout the cooling system and cause discoloration, corrosion and flaking of metals, and pinholes. The cause of electrolysis is a loose or damaged ground on any electrical source or poor coolant pH balance.

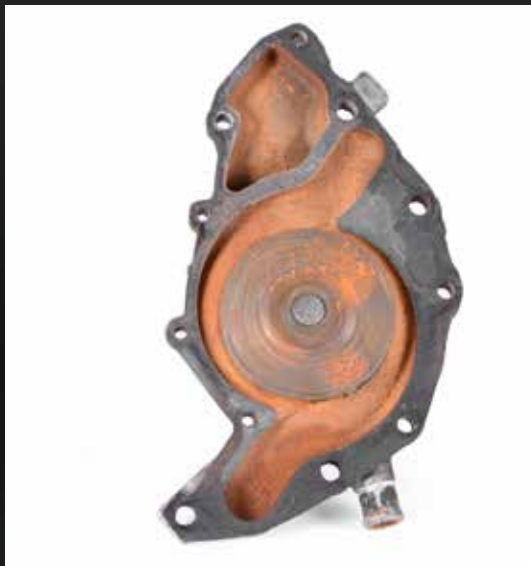
**Cooling System Problems:
Contamination**
Refer to Pages 16-17

Contaminated coolant can appear rusty if contaminated from oxidation or the consistency can become thick possibly from mixing different types of coolant. Leaks in the cooling system can introduce air into the coolant and cause degradation of the coolant and cavitation. Not using enough or using too much water mix can damage engine components and regular tap water can leave deposits of minerals that can clog the system and erode materials. The water used in a cooling system should be distilled. The type of coolant used is also an important factor in today's vehicles as different OEM's are using specific formulas as part of the engine design.

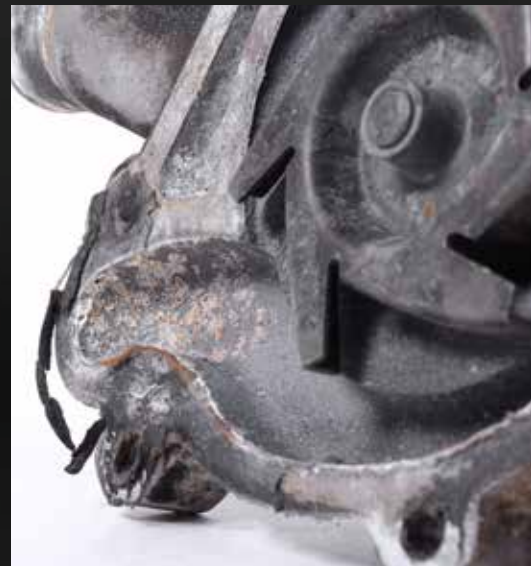
**Cooling System Problems:
Cavitation**
Refer to Pages 16-17

Cavitation is voids in the coolant filled with super-heated vapor that can erode both plastic and metal. Incorrect coolant and water mix is a major cause of cavitation. Restrictions in the coolant flow can cause the voids as well because of vapor pressure and suction generated by the pump.

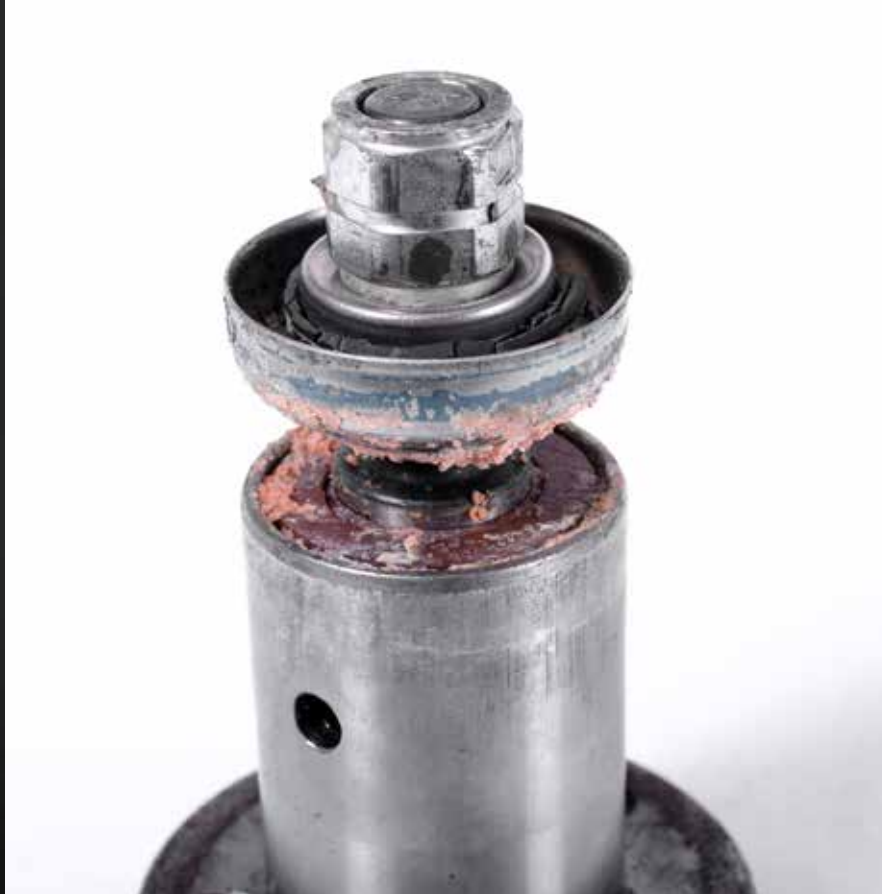
10 WATER PUMP SEAL FAILURE

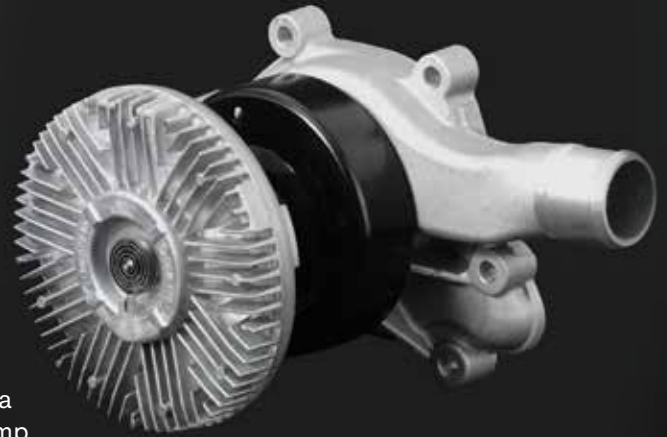
01

BEARING FAILURE

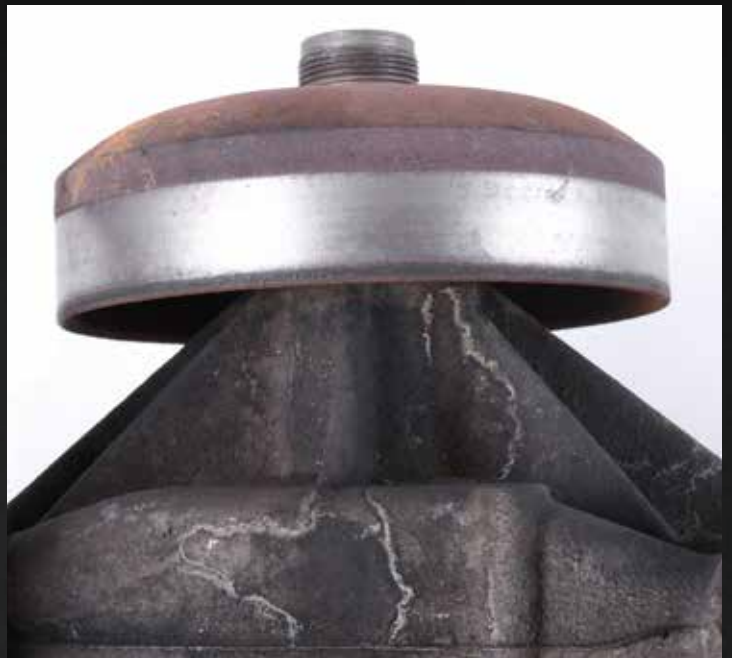
03

Notice in photo 03, the pulley is tilted at a slight angle, a sign that indicates bearing failure.

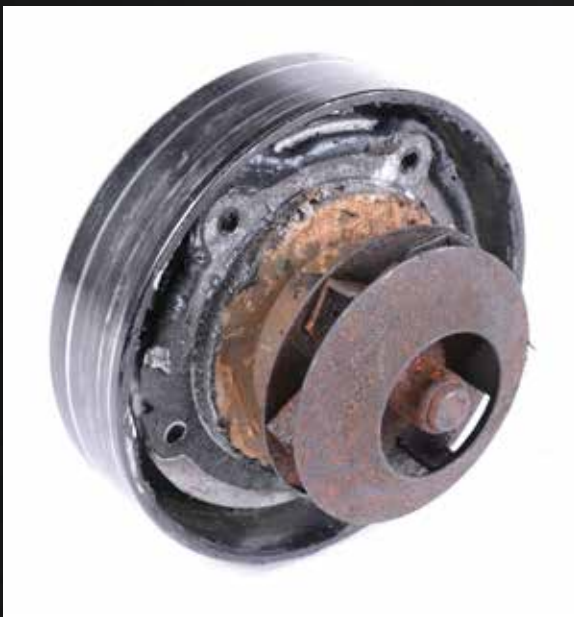
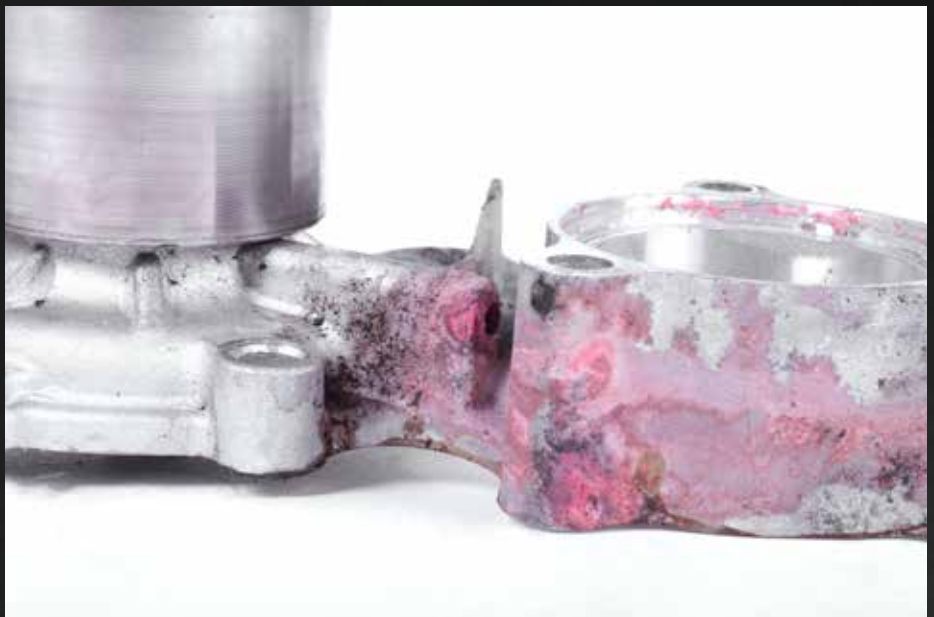
LEAKING WATER PUMP

The use of gasket sealant is not required on most water pump replacements and should only be used where the OEM design calls for it. Unless used in extremely limited amounts and precisely, any excess, exposed material will harden, become loose, and enter the cooling system causing blockage. This hardening can also cause voids in the sealing area and coolant will find its way out and appear as a faulty water pump.

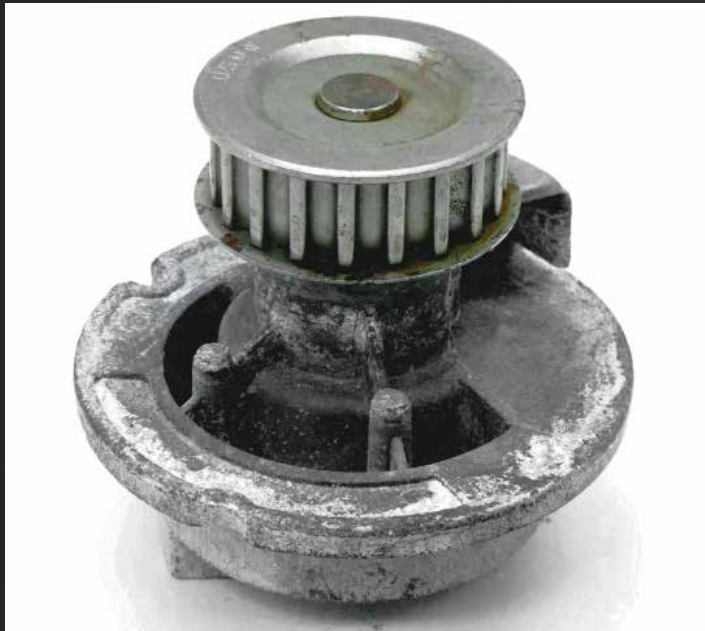
If the water pump that is to be replaced has these features, check the electrical system and review other accessible cooling system components for material discoloration or pitting. Never use the radiator as a ground. Poor cooling system maintenance can cause a coolant PH imbalance producing chemical electrolysis.

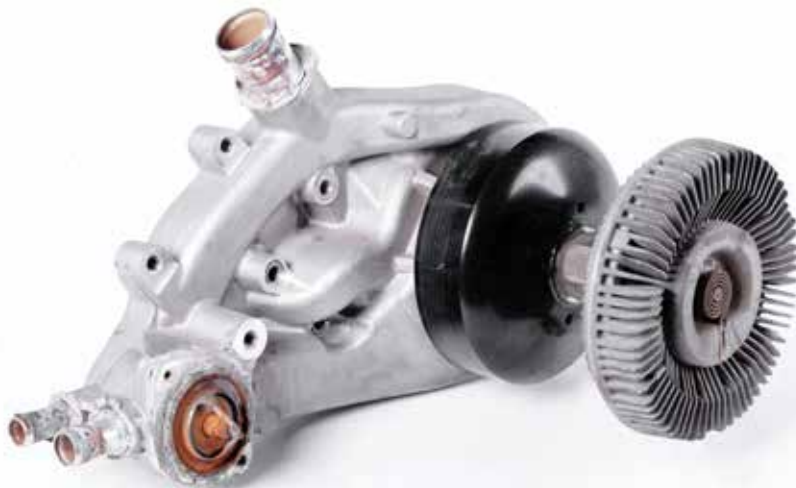
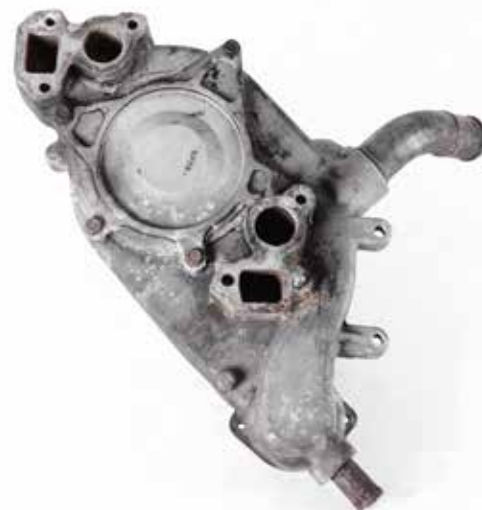
**New water pump with
old related parts**

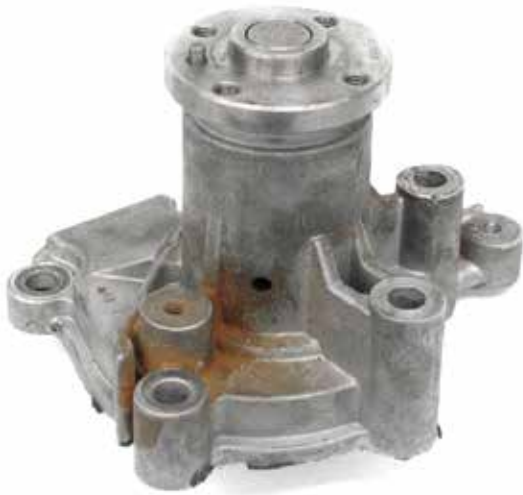
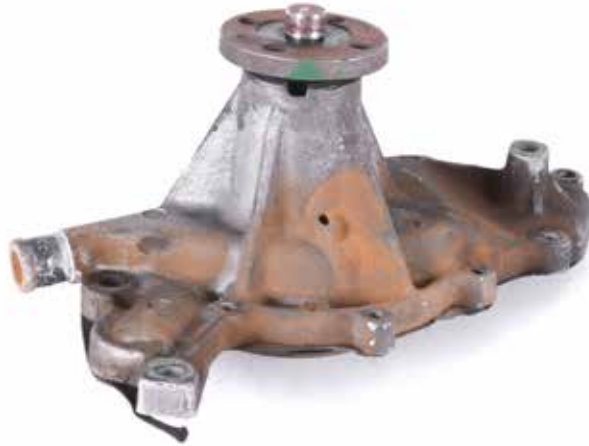
● **Poor AC/ F+W maintenance**
